PRE-CERCLIS SCREENING ASSESSMENT CHECKLIST/DECISION FORM

Site Name: Edlow Lead Company

Site Location: 729 Bank Street, Columbus, Ohio / Franklin County
(See attached description and maps).

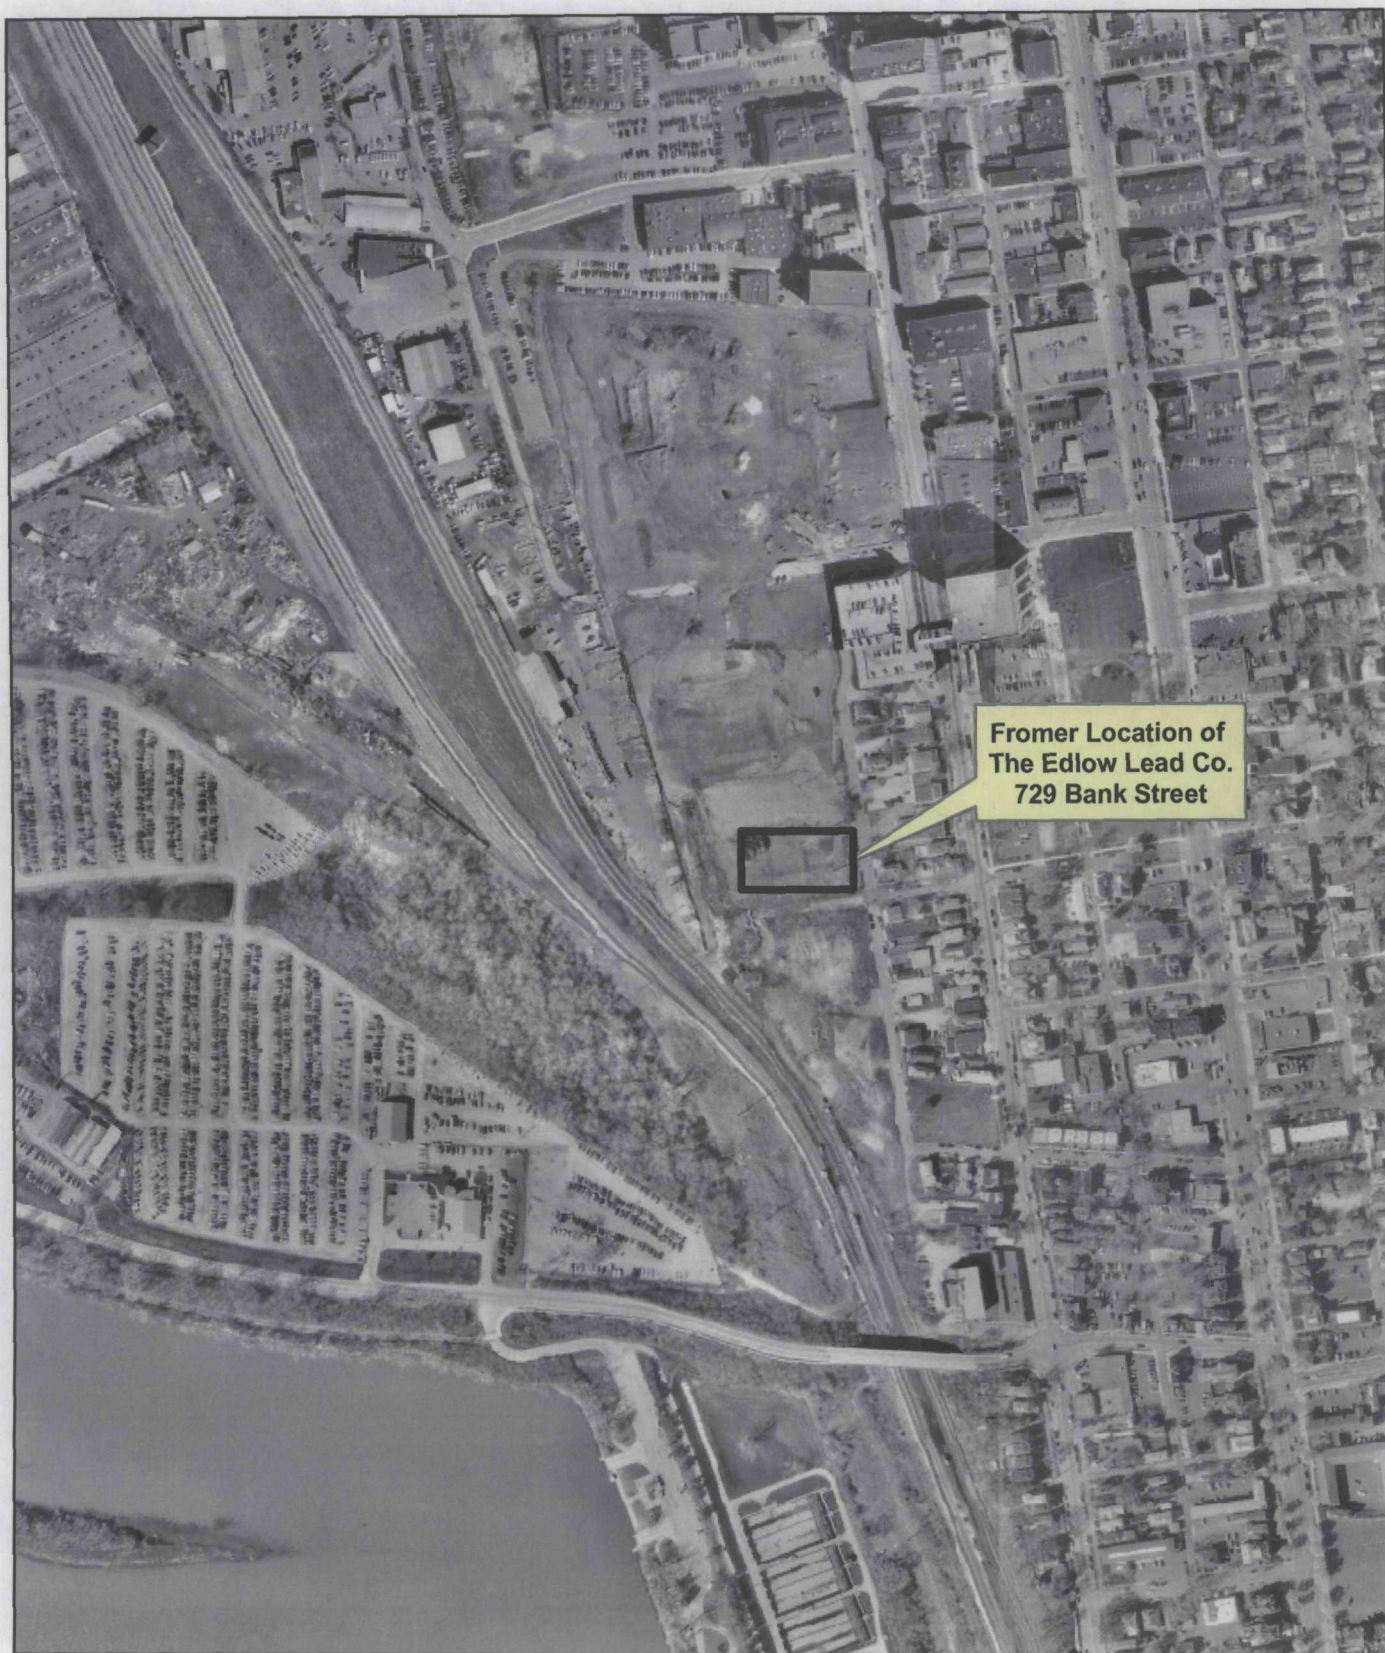
Figure 2: Site Location Map
Edlow Lead Company
2000 Aerial Photograph

The former Edlow Lead Company was located at 729 Bank Street in Columbus, Ohio. According to the Franklin County Auditor's Office, the 729 Bank Street address no longer exists but was located at the northwest corner of Bank and Frankfort Streets in Columbus. The site location and surrounding area can be seen on a USGS Quadrangle, **Figure 1**, and a 2000 aerial photograph, **Figure 2**. The property is now part of a large apartment complex (See attached photographic log).

Former Location of
The Edlow Lead Co.
729 Bank Street

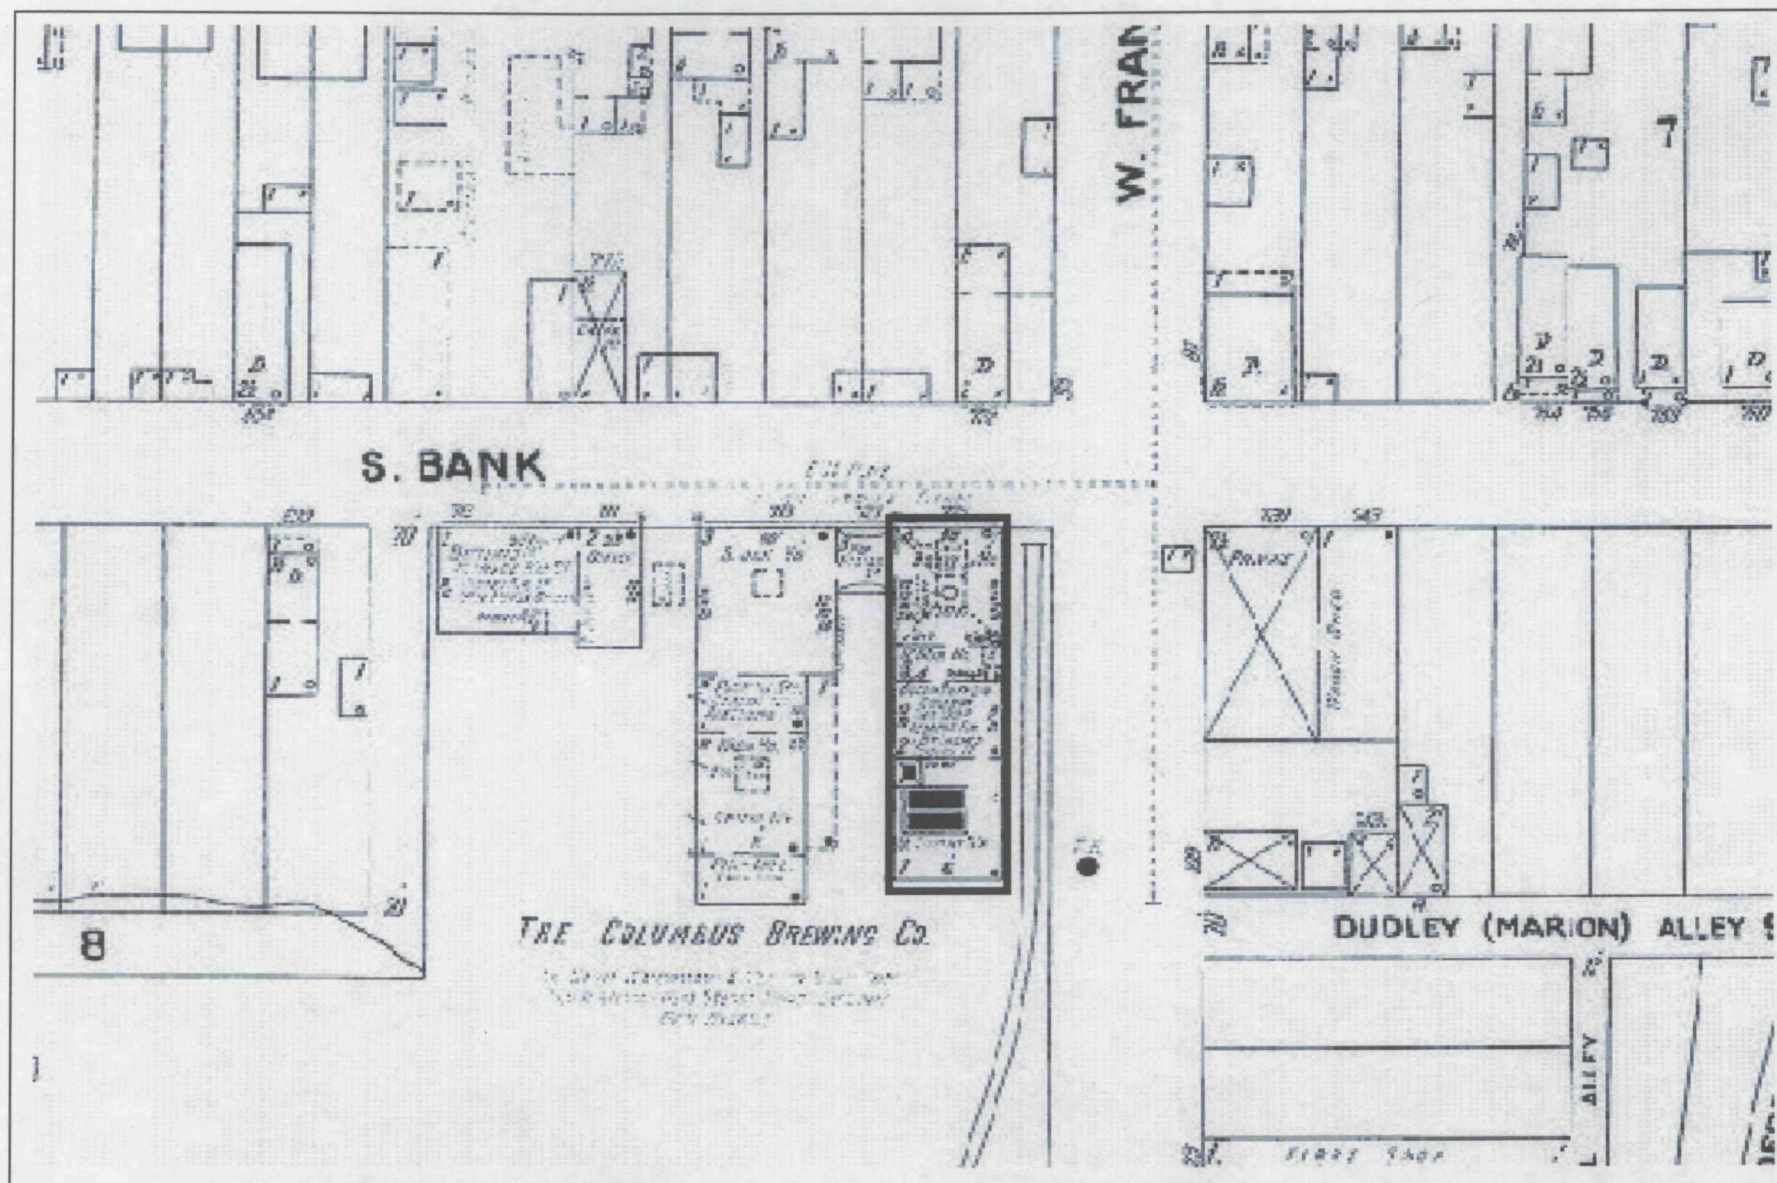
Figure 3:
1901 Sanborn Fire Insurance Map
Edlow Lead Company

According to the historical Polk Columbus City Directory, the 729 Bank Street address first appeared in 1901. This was the site of the Columbus Brewing Company, Branch 4 of Hoster - Columbus Association of Breweries. A 1901 Sanborn Fire Insurance Map, **Figure 3**, also shows the Columbus Brewing Co. at this location.

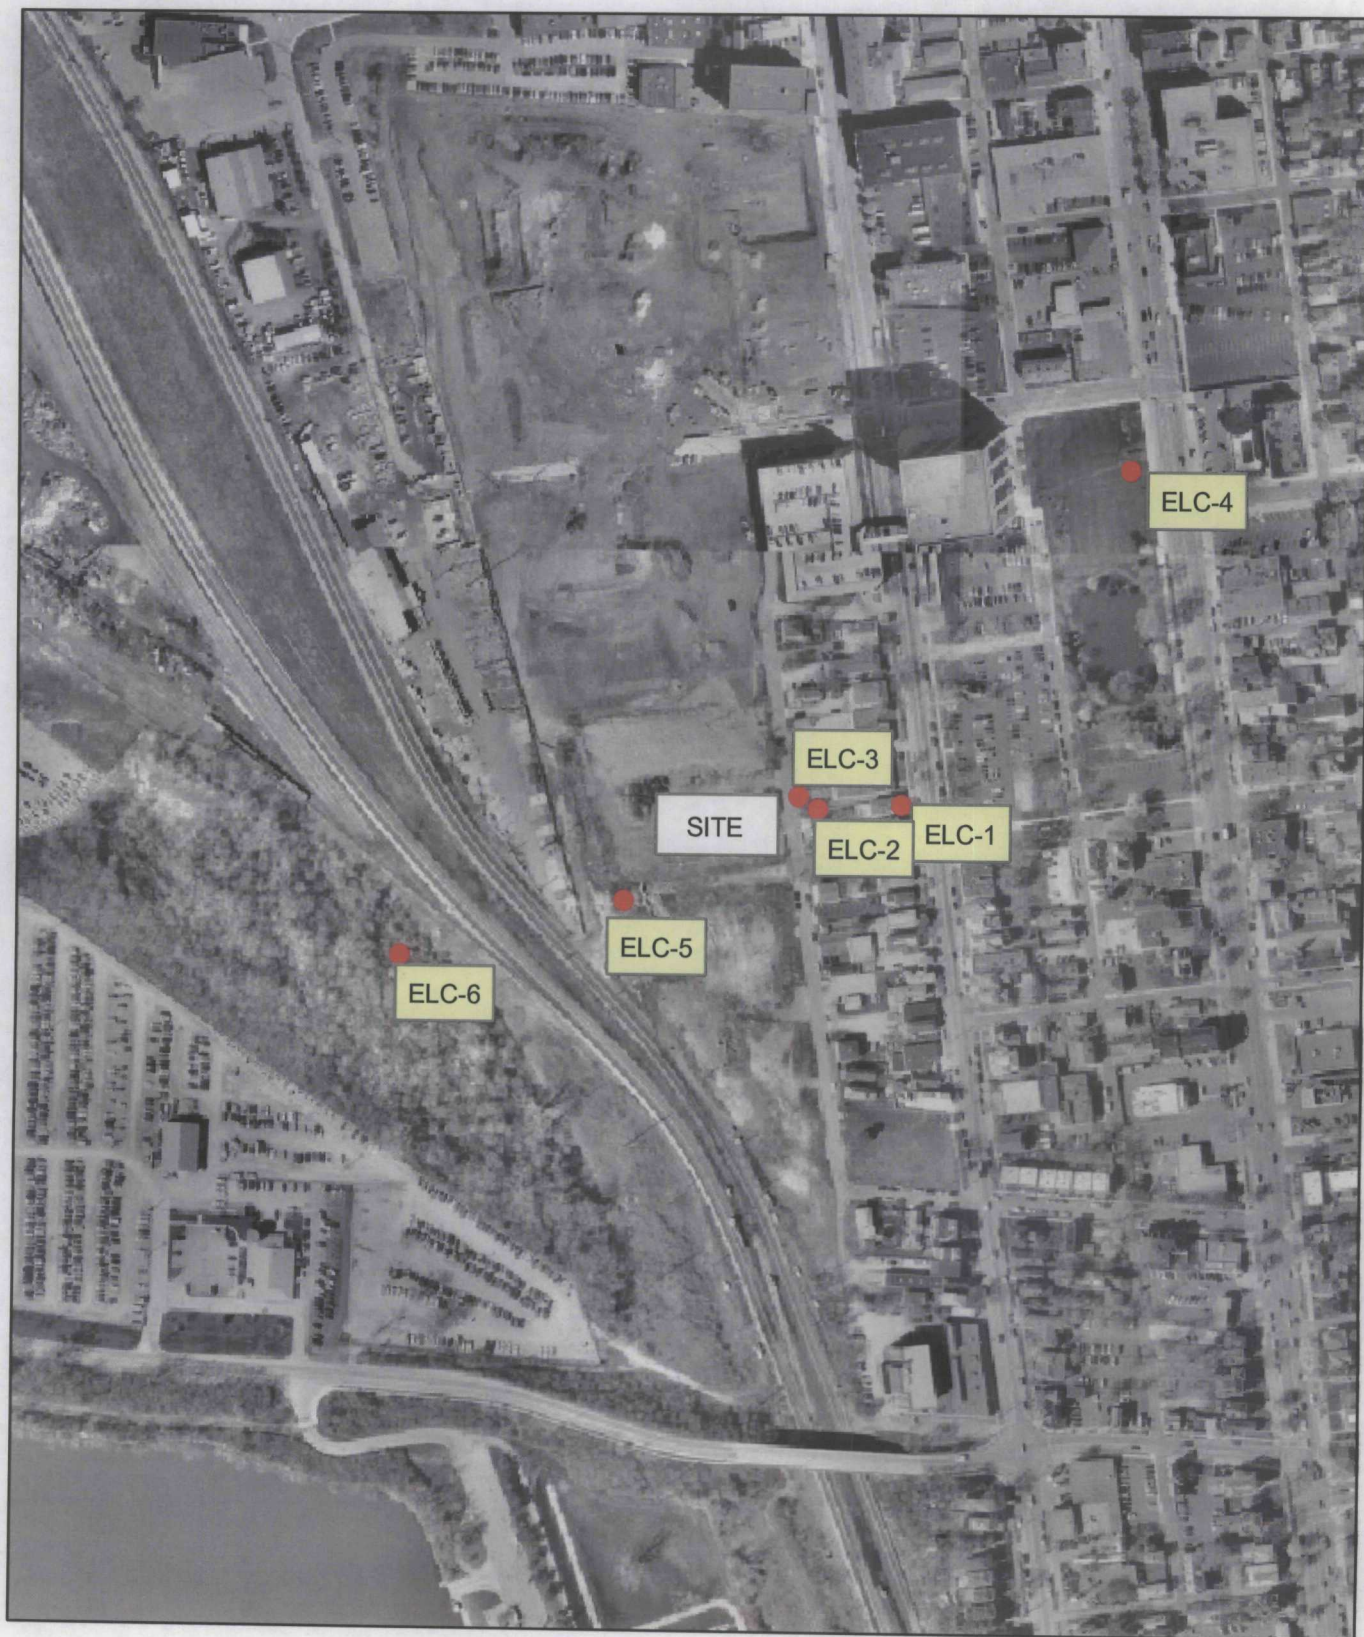
Figure 4: Sample Location Map
Edlow Lead Company
2000 Aerial Photograph

The samples were collected on March 26, 2003 and were numbered ELC-1 through ELC-6. Sample locations can be found on the aerial photo in **Figure 4**. The sample locations were chosen based on accessibility and potential targets. Additionally, an attempt was made to collect samples in all directions, particularly downwind of the site.

Sample ELC-1 through ELC-2 were collected in the front and back yard of a residence located at 723 Front Street. The home is located east of the site, directly across Bank Street. It is downwind from the site. The family has owned the home since the 1920's. The samples were collected from the native soil of the residence. All the results were well below the 400 ppm PRG for residential soils.

Sample ELC-4 was collected at Shiller Park and is considered the background sample. The confirmation result of ELC-4 was less than a 1% difference to the XRF result. Sample ELC-5 was collected off a slope on the south side of the site. Both these samples were below 400 ppm.

Sample ELC-6 was collected over the rail road tracks that border the site to the south. This area can be considered industrial, and was above the 750 ppm PRG for industrial soils. This sample was also sent to Kemron for confirmation. The Kemron result was 85% higher than the XRF result. It is unknown why this occurred, but it may have to do with sample homogenization.

From the limited samples collected, it does not appear the site has caused a lead problem in area. Therefore, no further action is recommended. However, further investigation may be warranted for the area west of the former Edlow Lead site.
